MTL TR 91-33

LAV STRUT CAP STUDY

September 1991

US ARMY
LABORATORY COMMAND
MATERIALS TECHNOLOGY LABORATORY

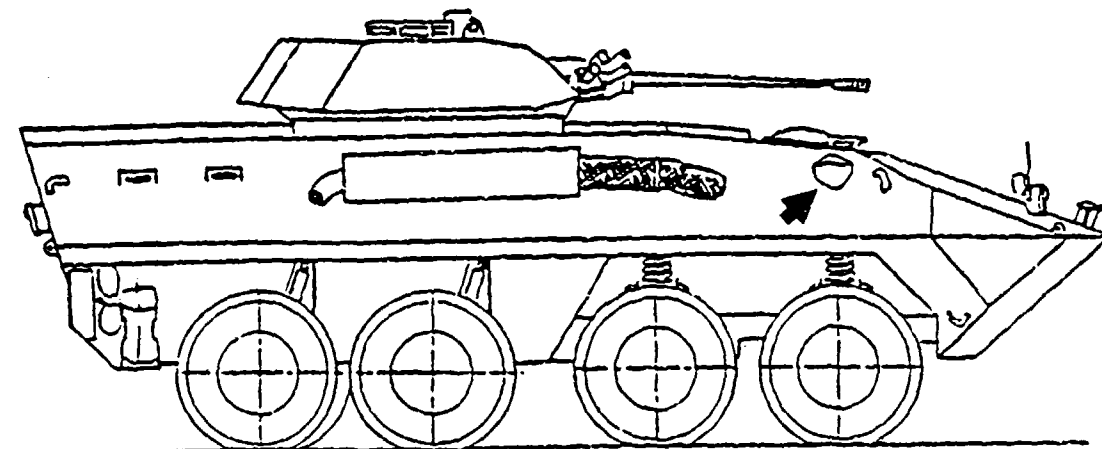
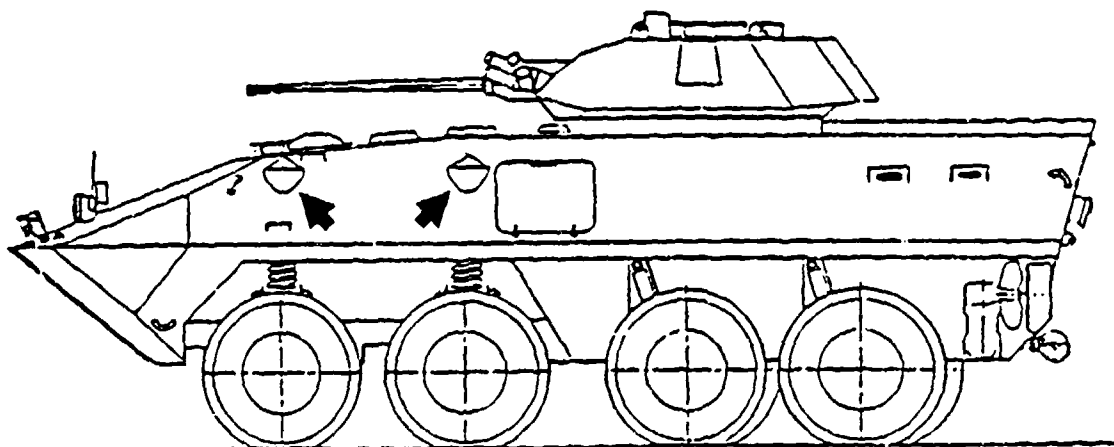
There are four strut cap assemblies on each vehicle at the top of the two strut towers for the front two wheels on each side. The location of these caps is shown in Figure 1. Each assembly is composed of two curved pieces of high hard steel plate 6.31 mm (nominal) in thickness. They are fabricated entirely in the fully heat-treated (hardened) condition. The two components are first sectioned from a larger plate by underwater plasma-arc cutting followed by edge grinding. The cut sections are then cold formed to their final shape, as shown in Figure 2. Upon examination of the sections it appears that these are formed by sequential bending; i.e., they are clamped, bent a little, moved about 1-1/4 inches, bent some more, and so forth. The sections do not have a uniform, smooth curvature but instead exhibit ridges of high curvature with strips of relatively planar regions between them. This operation introduces a considerable residual tensile stress in the outside grains, particularly at the ridges where the plate has been bent to the smallest radius of curvature.

Figure 1. The locations of the four strut cap assemblies on the LAV are shown by the arrows.

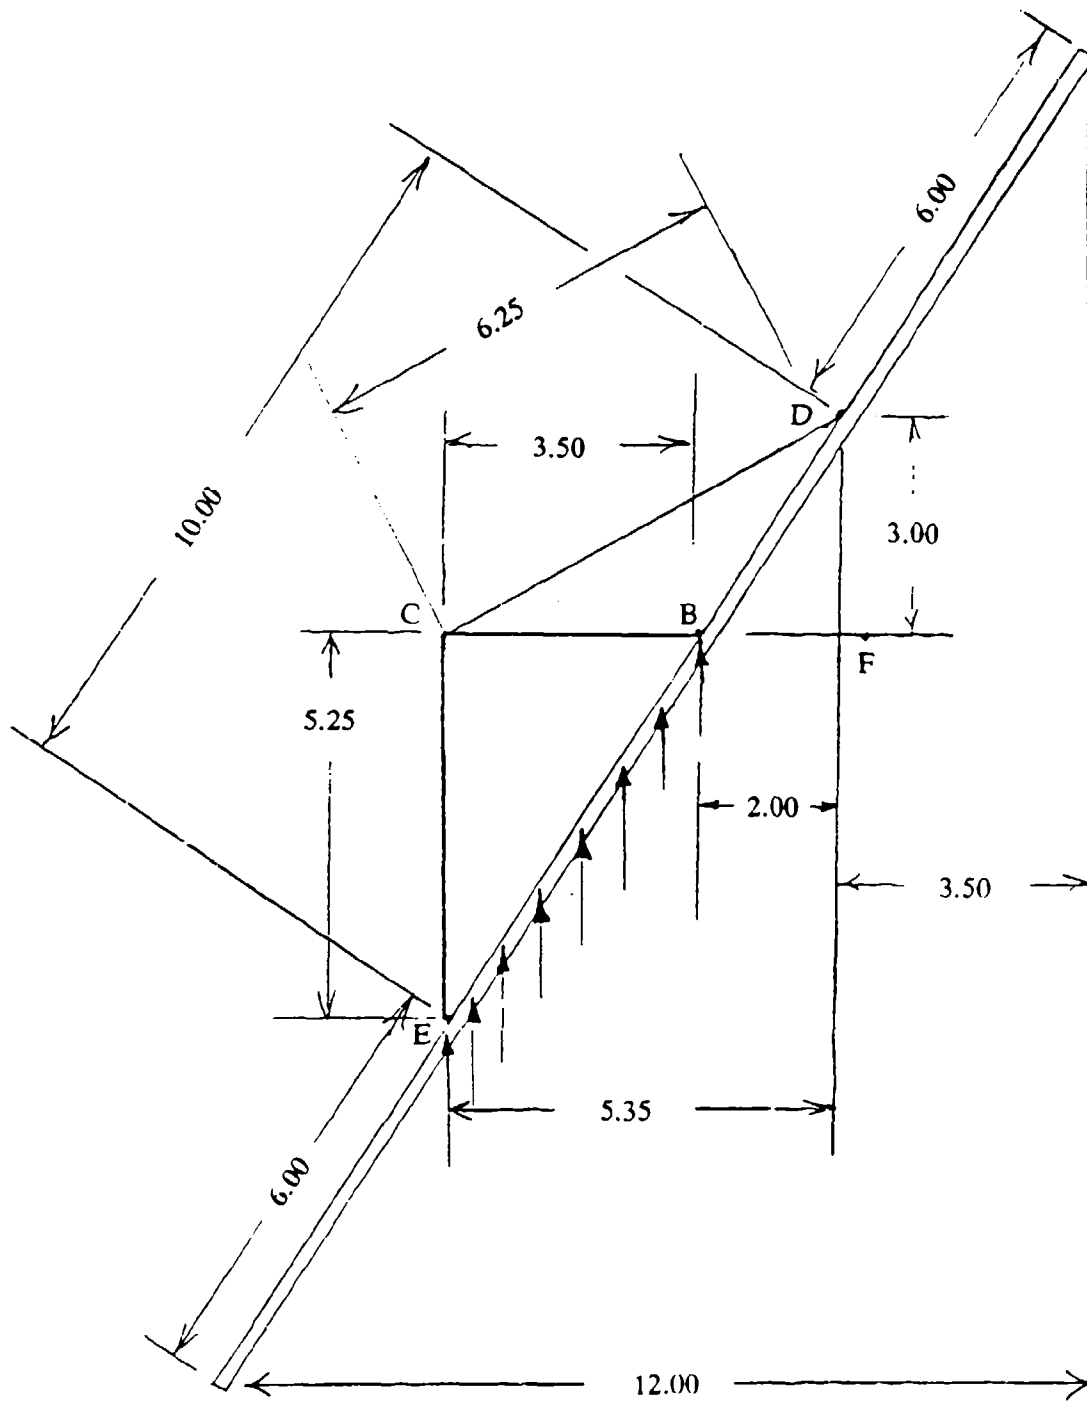
Figure 5. Side view from the front showing the dimensions of the two components of the strut cap assembly on the LAV.

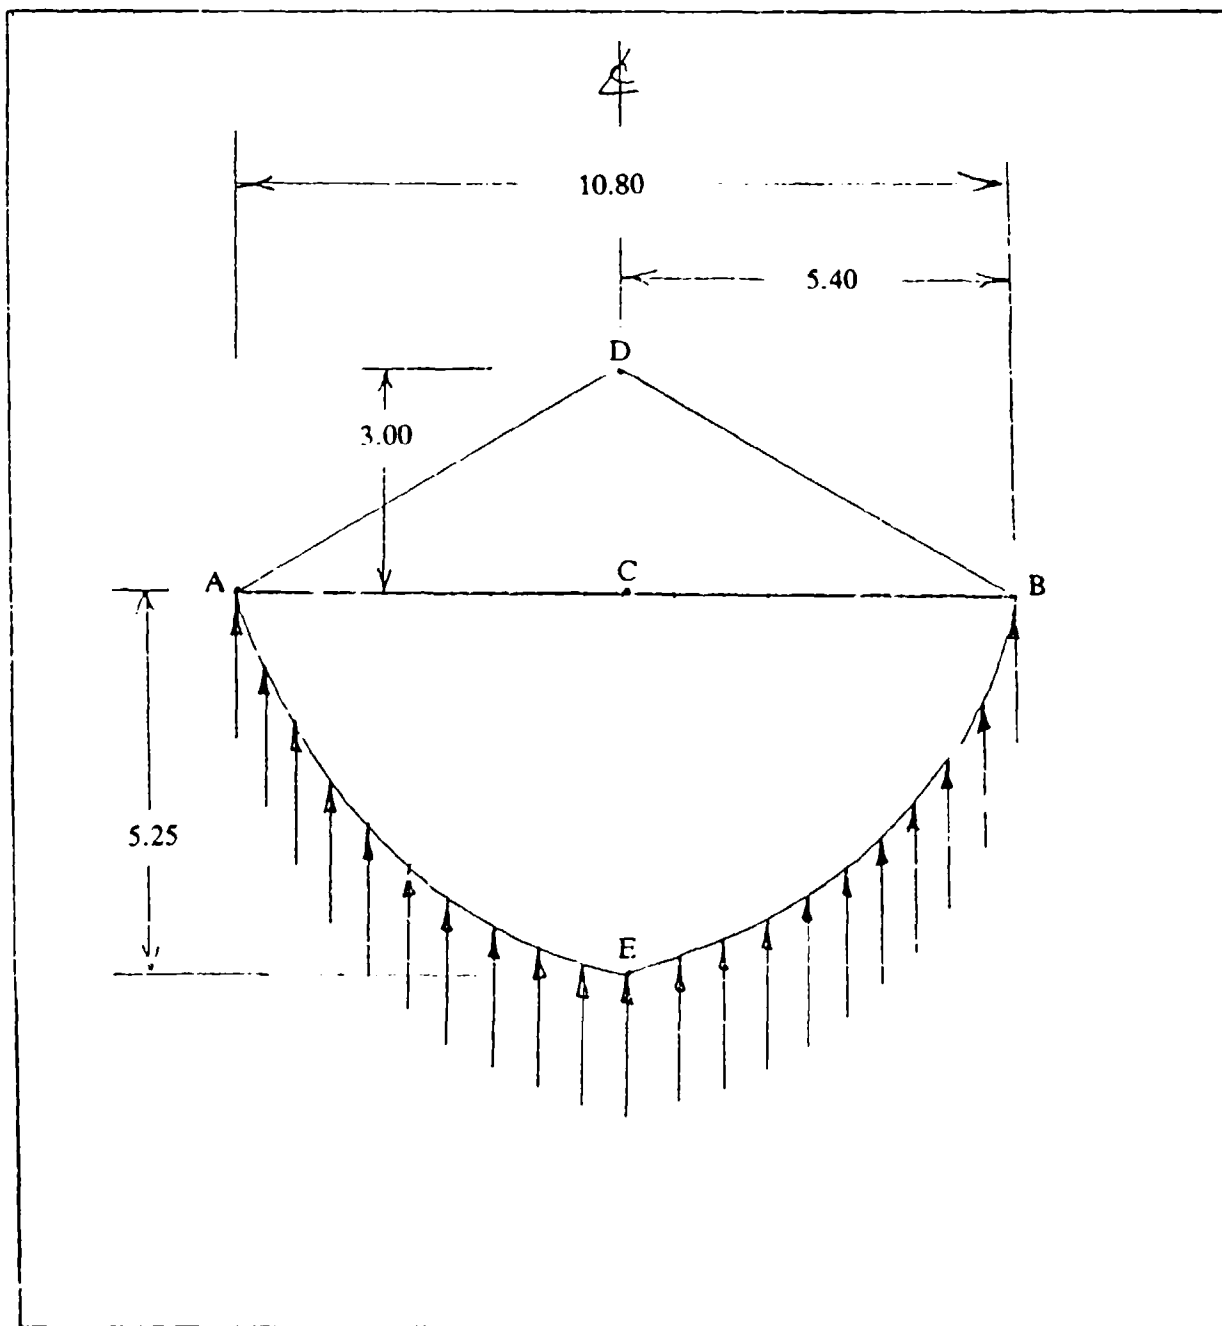
Figure 6. Side view from the side giving dimensions of the strut cap pieces on the LAV

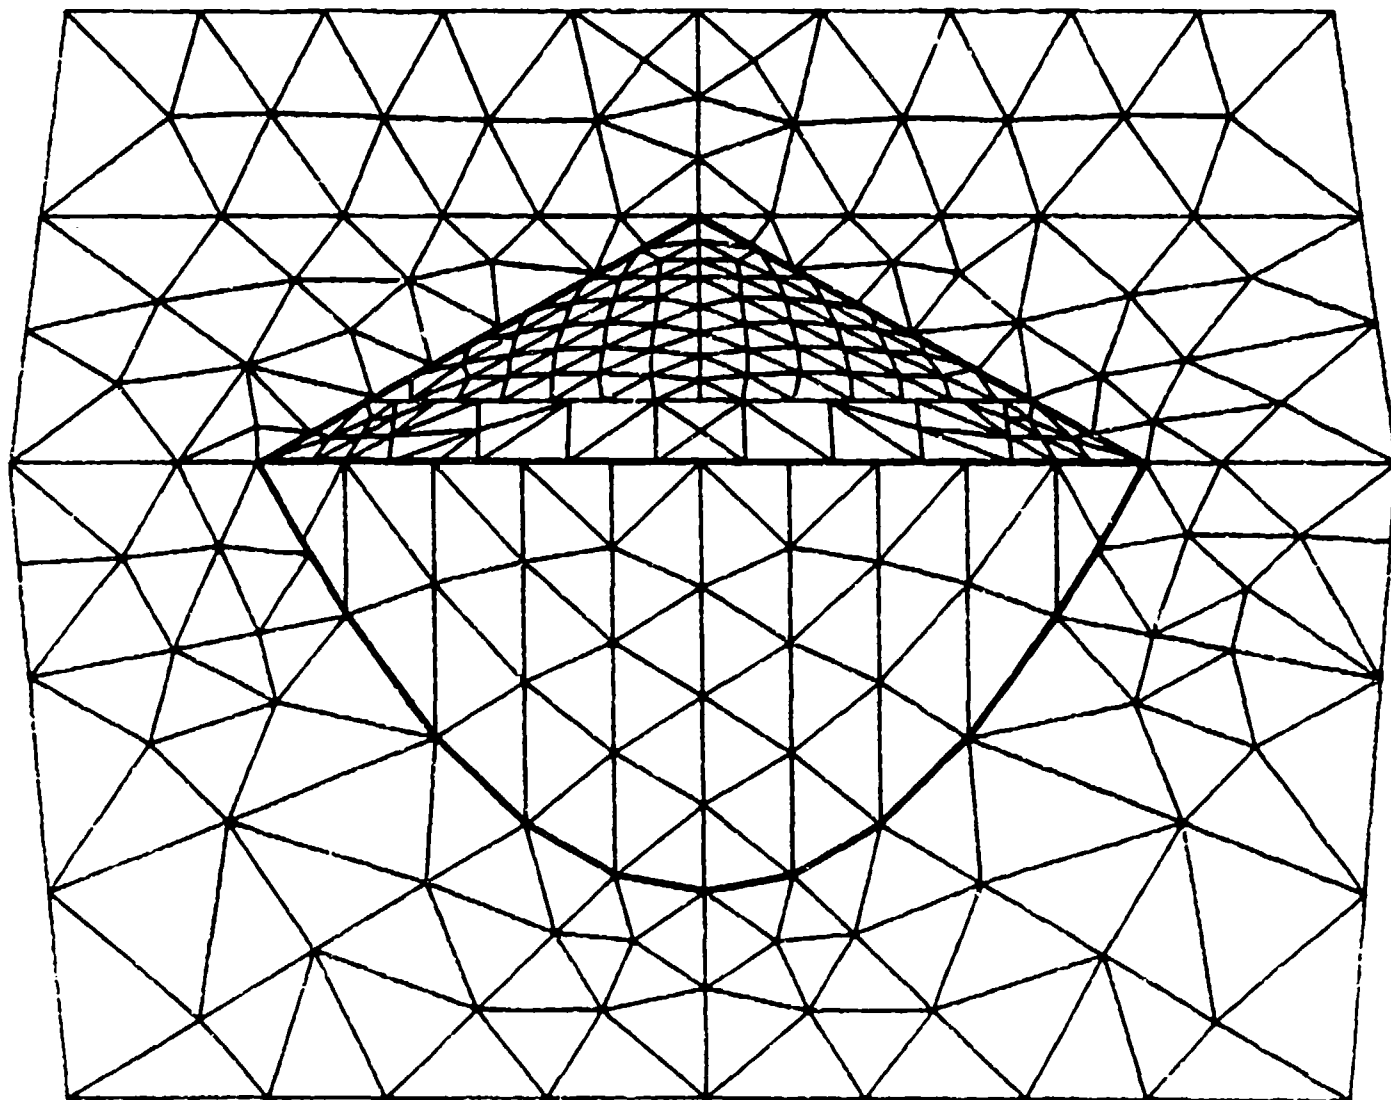
STATIC ANALYSIS OF STRUTCAP
TOTAL FORCE OF 500LBS PER NODE

A finite element analysis was conducted to determine the stress field existing in the strut cap and in the surrounding structure. Actual dynamic loads generated when normally operating the vehicle are presently not available, so an equivalent static load was applied to the strut cap in the area where it is joined to the shock tower. The strut cap and the surrounding structure, shown in Figures 5 and 6, were modelled using the Numerically Integrated Elements for System Analysis (NISA II) finite element code² to conduct an elastic static analysis. The results to be discussed do not determine the maximum stress values but only the stress field which exists during dynamic loading. The stress field can be used to determine if the design tends to equally distribute the stresses due to loading. If not equally distributed, the stress field will show areas where the stress is concentrated and there is a probability of material failure.
